# 电能质量

Power Quality Management

Product Manual

Active Harmonic Filter

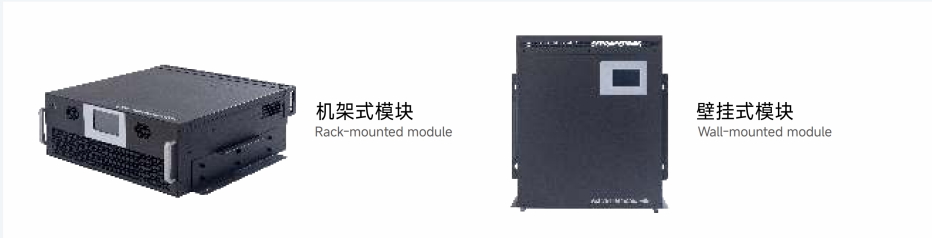
GY-AHF

有源电力滤波装置（GY-AHF）的工作原理是实时检测负载电流，基于指定次谐波电流检测算法将谐波电流逐次分离，按照设定的滤波百分比生成控制信号，驱动 IGBT 输出与负载谐波电流幅值相同相位相反的补偿电流，实现谐波补偿功能。

The working principle of the active power filter device (GY-AHF) is to detect the load current in real time. Based on a specified sub harmonic current detection algorithm, the harmonic current is gradually separated, and a control signal is generated according to the set filtering percentage to drive the IGBT to output a compensation current with the same amplitude and opposite phase as the load harmonic current, achieving harmonic compensation function.

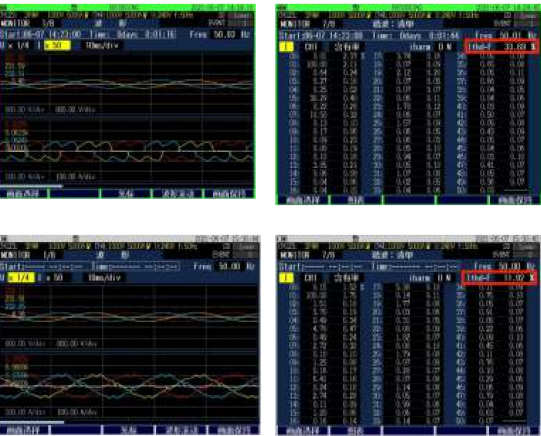
**治理方案:** 在低压配电室安装690V APF进行谐波治理, 装完后此系统的电流畸变率降低至GB/T 14549标准要求, 治理效果显著。抽油机运行状态良好, 无误动作及停机事件发生。

**Solution:** A 690V Active Power Filter (APF) was installed in the low-voltage distribution room for harmonic mitigation. After installation, the current distortion rate of the system was reduced to meet the requirements of the GB/T 14549 standard, achieving significant improvement. The pumping units have been operating in good condition, with no malfunctions or shutdowns.

| 电流畸变率对比<br>Current distortion rate comparison | |
